Five Star Home Inspections

Home Condition Report

12345 Five Star Road, Kansas City Metro

Inspection Date: June 1, 2014

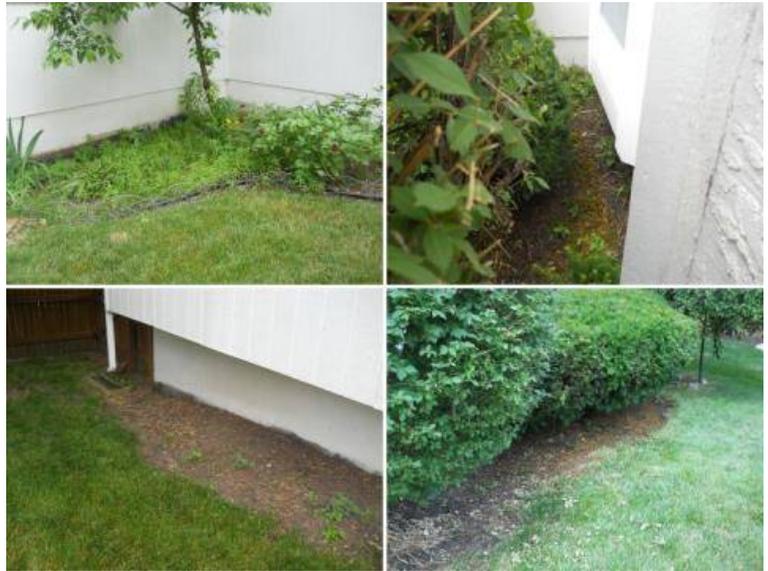
Perimeter Foundation Drainage Surface:

Attention Needed - The drainage around the foundation should slope away from the foundation at a rate of 1/2" per foot for 6' from the foundation. Portions of the ground around the perimeter do not meet this minimum standard. Portions of all four sides of the home need some grading adjustment.

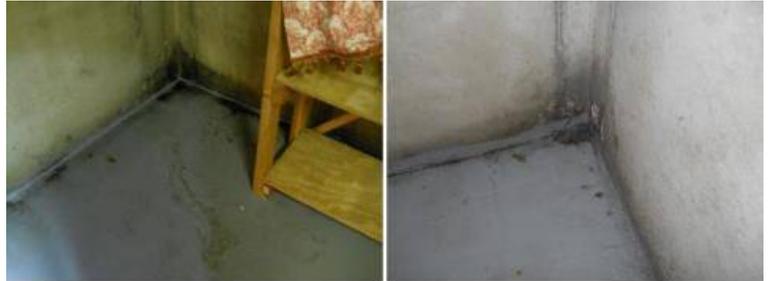
Evidence of Water Entry in the Basement Noted:

Action Necessary - There is evidence of water entry in the basement at the rear foundation wall. It is recommended that a professional foundation contractor fully evaluate the basement and determine the best cause and cure for the water entry.

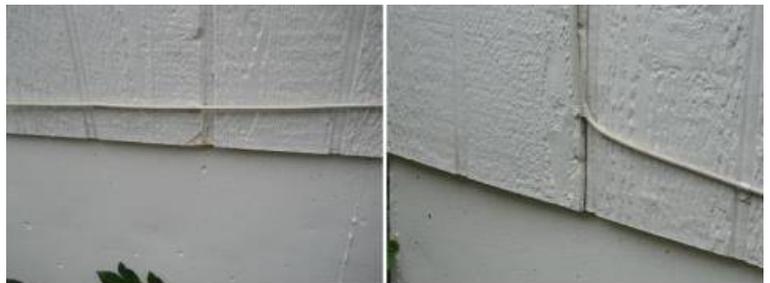
Siding Condition:

Attention Needed - The exterior siding material or finish is in a condition that requires minor repair to prevent further deterioration. There is some siding deterioration in need of repair in the lower portions of the siding on the east and west sides of the home and in the siding seams on the east side of the home. It is recommended that a professional siding contractor evaluate the siding and make recommendations to prevent further deterioration.

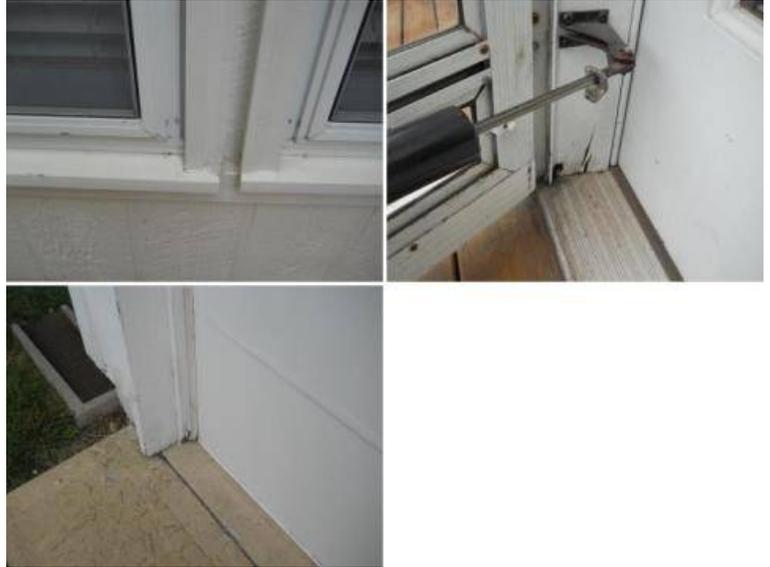
Trim Condition:

Attention Needed - The trim needs some minor repair to prevent further deterioration. There is trim deterioration in need of repair around the front left garage door, in the trim around the center west facing breakfast room window, and in the trim between the rear entry door and the storm door.

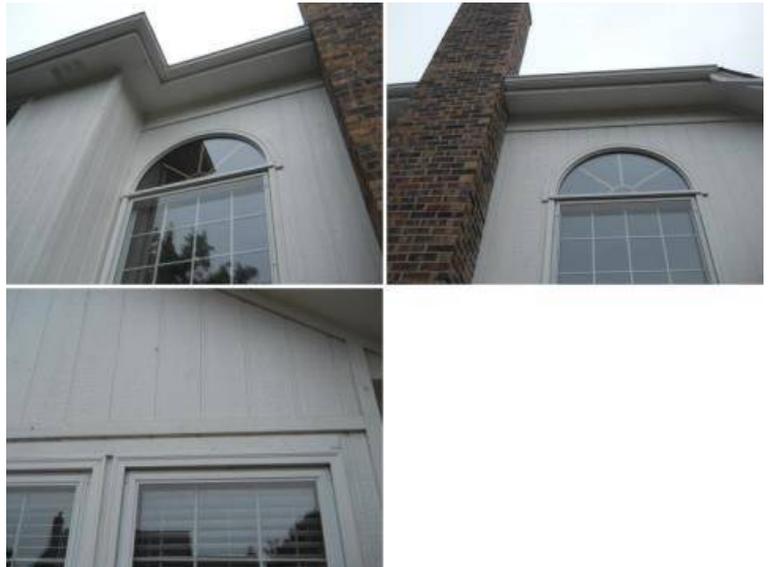
Window Flashing:

Attention Needed - The installed window flashing does not appear to be adequate. Some repair is necessary. The flashing above the center and right rear breakfast room windows needs to be repaired so the flashing folds over the top of the trim. Also, there is missing flashing above the 1/2 moon windows in the family room that should be installed.

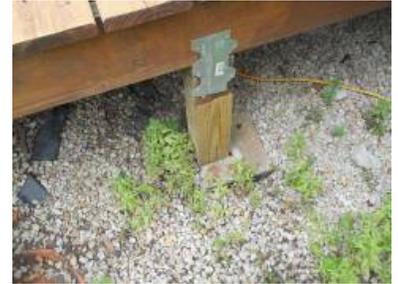
The Foundation Materials:

Action Necessary - The deck support posts are setting on a concrete slab. There is a possibility that one of the posts could become dislodged and result in deck support failure. All of the deck posts need to be anchored to concrete the concrete footings.

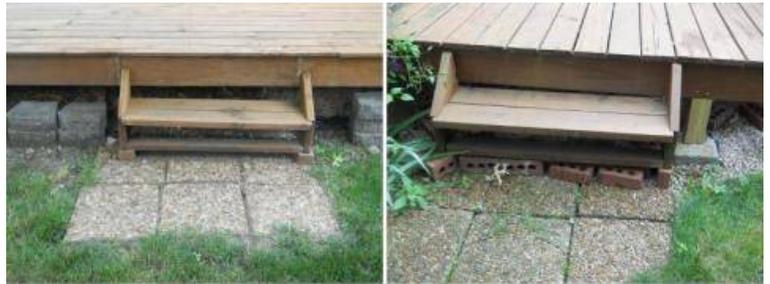
Stairs Condition:

Action Necessary - The steps for the deck have uneven and too tall of risers. All three sets of the deck stairs need to be repaired for safety to prevent tripping.

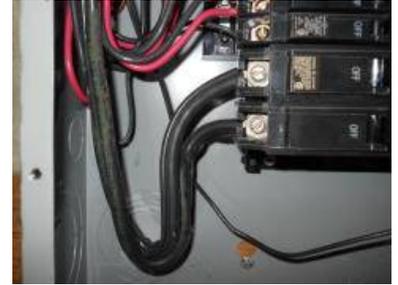
Condition of Wiring in Panel:

Action Necessary - Electrical circuitry wiring in the power panel shows some condition that calls for immediate action of a Qualified Licensed Electrician. Excess sheathing was noted on at least one romex cable entering the panelbox. This sheathing should be removed to within 1/4" to 1/2" of entering the panelbox.

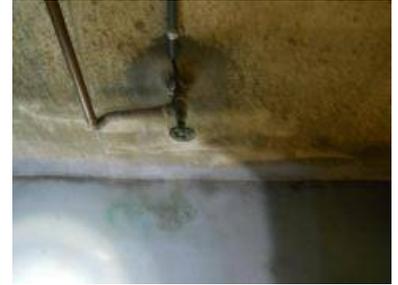
Leaks in the Supply Piping Noted:

Action Necessary - There is a leak in the supply system. Services of a Qualified Licensed Plumber may be required. There is a leak at the main water cutoff in the basement.
