## Home Condition Report

**John Doe**  
**12345 Sample Street, Anywhere, USA 99999**

**Inspected By:** Mike Blackman - Inspector  
Five Star Home Inspections, Inc.  
913-219-8634

**Inspection Date:** January 1, 2008

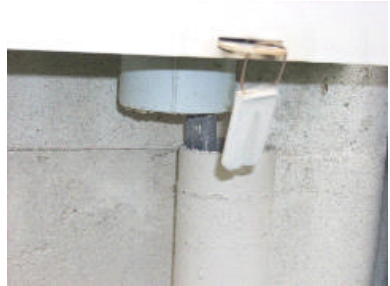
City.
Front yard several feet in from the street.
Good - Underground.
<p><b>Action Necessary</b> - The conduit for the incoming electrical line has pulled away from the meter can. The conduit needs to be properly secured to the meter can for safety.</p>

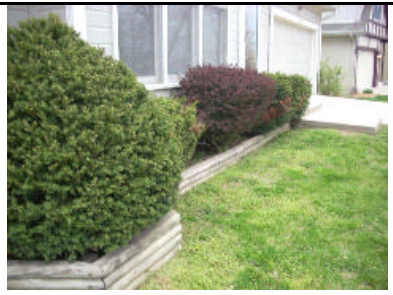
<b>Type of Foundation:</b>	Utility Basement - Basement with foundation walls below grade tall enough to have living space and a finished floor.
<b>Foundation Materials:</b>	Poured-in-place concrete, 8" or more thick.
<b>Visible Portions of Exterior Foundation Walls:</b>	The exterior view of the foundation is limited to the portions visible above grade. Only about 5% to 10% of the foundation was visible. Areas not visible are not commented on as a part of this inspection.
<b>Visible Foundation Wall Cracks Noted From Exterior:</b>	Shrinkage cracks are hairline cracks that are caused by the evaporation of water in the mix. This is a normal condition. Seventy-five percent of all shrinkage cracks appear in the first year.
<b>Evidence of Recent Movement:</b>	No - There is no evidence of any recent movement.
<b>Perimeter Foundation Drainage Surface:</b>	<p><b>Attention Needed</b> - The drainage around the foundation should slope away from the foundation at a rate of 1/2" per foot for 6' from the foundation. Portions of the ground around the perimeter do not meet this minimum standard. Front Wall, Right Wall, Left Wall.</p>

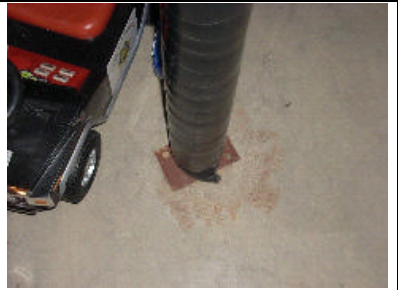
There are steel columns or posts installed.	
<p><b>Action Necessary</b> - The main support columns or beams do not appear to be adequately fastened at both ends.</p>

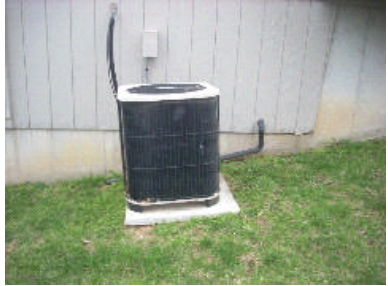
<b>Model/Serial Number/Size:</b>	Lennox - Manufactured in 1993. The typical service life for an AC unit is 12 - 15 years. Although this unit was operational during the inspection, the age and/or condition is such that you may need to replace it in the near future.	
<b>Type:</b>	Refrigerator/Split System. Electricity-powered.	
<b>Unit/Condenser Location:</b>	Side of the house.	
<b>Unit Tested:</b>	Yes.	
<b>Insulation Wrap on the Suction Line:</b>	<p><b>Attention Needed</b> - The entry hole for the air-conditioning line set needs to be sealed with a caulk or insulating material to prevent moisture, insects, or animals from entering.</p>

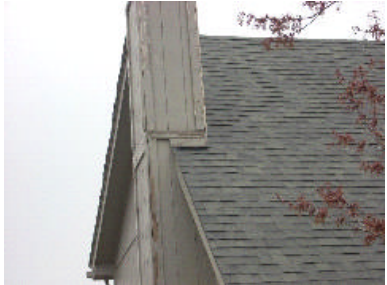
<b>Roof Covering Materials:</b>	Asphalt composition shingles. These consist of cellulose mat, asphalt impregnated with colored gravel on surface. Applied in horizontal rows.
<b>Cover Layers:</b>	The roof covering on the main structure appears to be the first covering.
<b>Underlayment Noted:</b>	Asphalt impregnated felt underlayment was noted under the roofing material in at least 2 locations that were checked.
<b>Condition of Roof Covering Material:</b>	Satisfactory - The roof covering material is in a condition that is consistent with its age and method of installation, showing no deficiency or cause for immediate concern.
<b>Estimated Life Expectancy of Roof:</b>	The roof covering material appears to have a remaining life expectancy of 10 years or more, assuming proper maintenance is completed as needed.
<b>Slope:</b>	Medium slope is considered to be between 4 in 12 and 6 in 12.
<b>Flashing:</b>	<p><b>Attention Needed</b> - Some portion of the roof flashing needs repair. The chimney flashing has raised and needs to be secured down.</p>

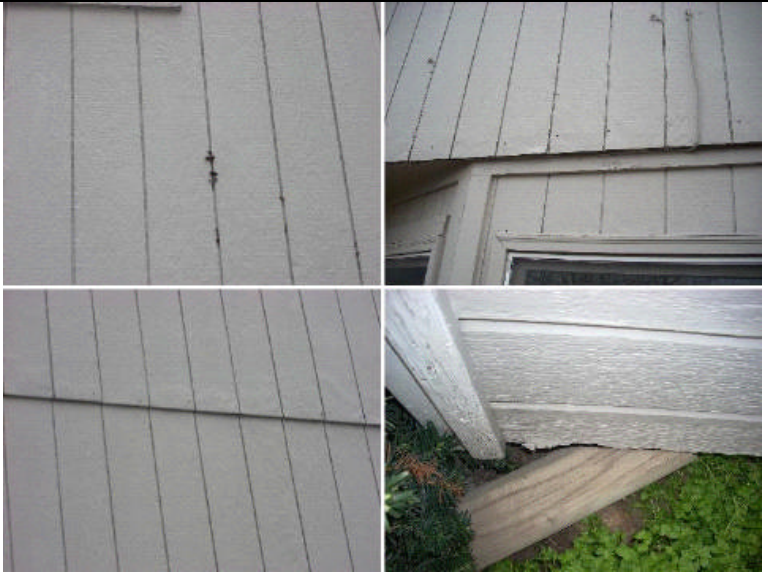
**Action Necessary -**  
 Some portion of the exterior siding material or finish is in a deteriorated condition that requires repair or replacement. There are multiple areas around the home that have rotted and damaged siding that is in need of replacement. It is highly recommended that all of the siding is professionally evaluated by a siding professional and repair or replace all damaged and deteriorated areas. There may be some hidden damage behind the siding. Have a professional contractor evaluate for hidden damage and make necessary repairs.

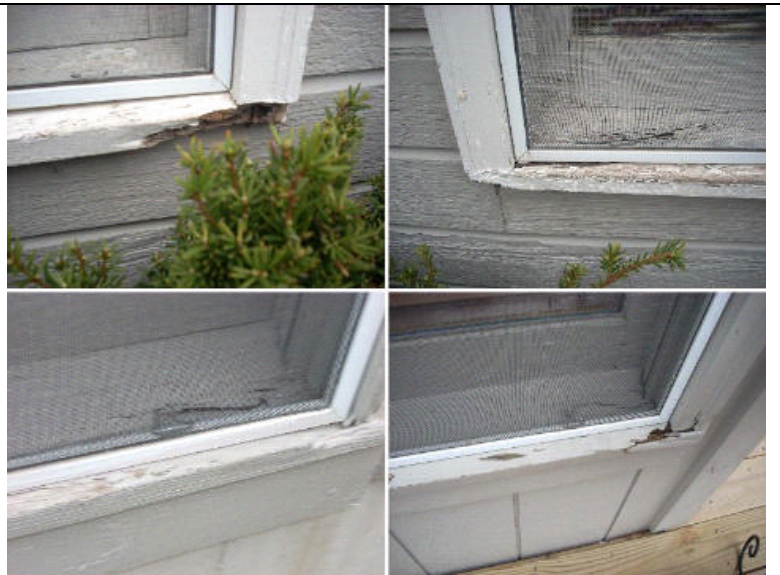
**Action Necessary** - Some portion of the trim currently is deteriorated to the point that it needs replacement. There is wood rot in over 80% of the windows sills and trim. It is highly recommended that all of the trim and sills are evaluated and repaired by a professional contractor.

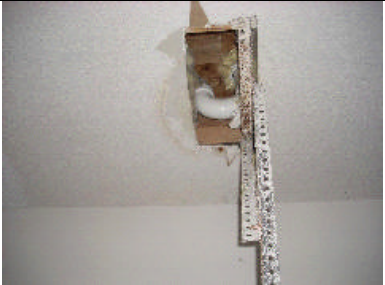
<b>Garage Type:</b>	The garage is attached.	
<b>Size of Garage:</b>	Two-car garage.	
<b>Number of Overhead Doors:</b>	There is a single overhead door.	
<b>Overhead Door and Hardware Condition:</b>	Satisfactory - The overhead door is in satisfactory condition, and it is functional.	
<b>Automatic Overhead Door Opener:</b>	The overhead door opener appears to function appropriately.	
<b>Safety Reverse Switch on the Automatic Opener:</b>	Yes - The door opener is equipped with an automatic safety reverse switch.	
<b>Floor Condition:</b>	Satisfactory - The garage floor is in satisfactory condition.	
<b>Garage Walls Condition:</b>	The wall covering appears to meet the minimum fire separation standards. However, it is not possible to verify after the sheetrock is finished.	
<b>Fire Rated Ceiling:</b>	<p><b>Attention Needed</b> - There is at least one hole in the garage ceiling. This condition needs repair to make the ceiling fire rated. There are also signs of previous water leaks in the ceiling. It does not appear to be an active leak.</p>
